S-102 Event and Investigation Overview

CH2MHILL S102 Spill Event Investigation

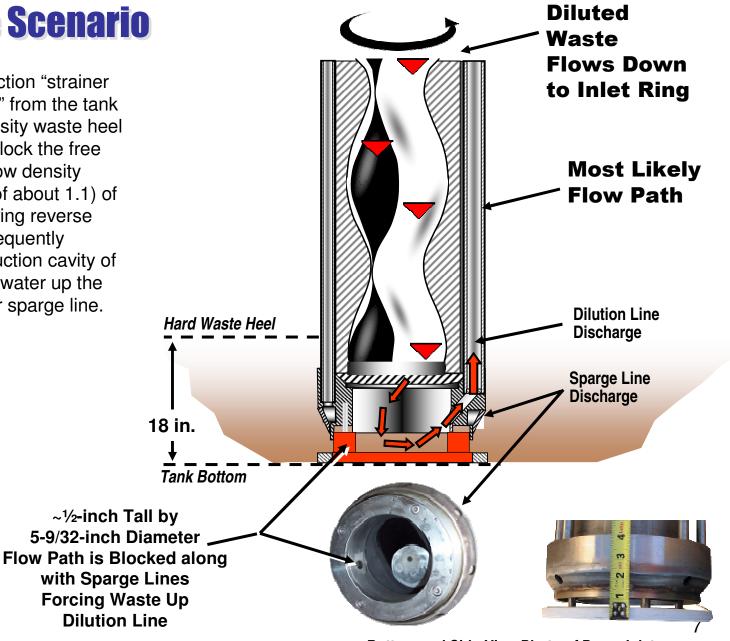
With the pump suction "strainer plate" within 1/2 - 1" from the tank floor, the high density waste heel was sufficient to block the free flow of relatively low density (Specific Gravity of about 1.1) of transfer waste during reverse rotation and subsequently pressurized the suction cavity of the pump, forcing water up the dilution line and/or sparge line.
